# Manhole Inspection Summary

Manhole # S05EE1013MH

Insp Date: **6/25/07 12:56 PM**

**Location** Address: **3915 OAKORD AVE**

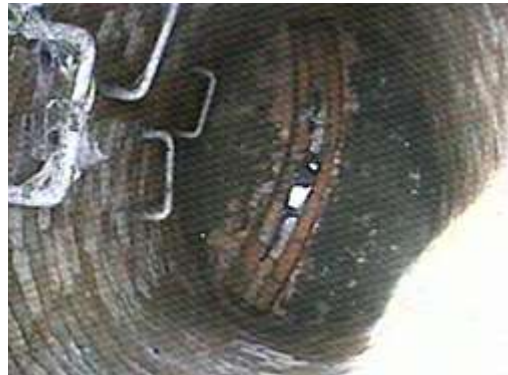
Top View

DEBRIS ON BENCH

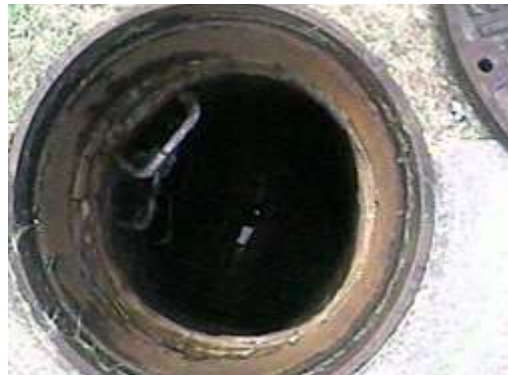
Defect 2

Condition: ☐ Sound ☐ Cracked ☐ Root Intrusion ☒ **Loose Brick** ☒ **Deteriorated**

LOOSE BRIKS AND DETERIORATED CORBEL

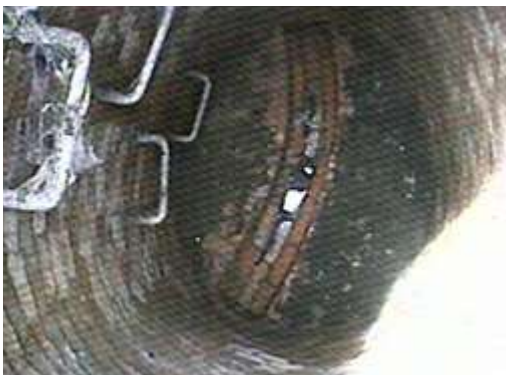
Defect 1

**Surcharge** ☒ **Evidence Of Surcharge** Depth: **2** (ft.) ☐ Active Surcharge Present

EVIDENCE SURCHARGE

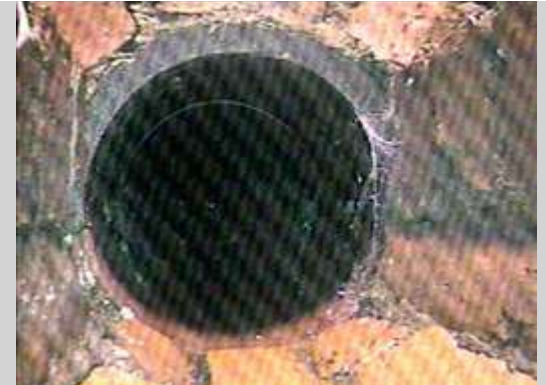
12 O'Clock Outflow

8 in. Circular Gravity Sewer  
Pipe Out @ 12 O'Clock

Pipe Height: (in.) Direct  
Pipe Material: **Clay** ☐ Pipe Lined  
Invert Depth: **9.04** (ft.) Flow Characteristics: **None**  
Deposits: ☒ None ☐ Mud ☐ Sludge ☐ Debris ☐ Grease  
Silt Depth: (in.) Deposits Extent:  
Infiltration: **None** Pipe Seal Cond: **Sound**

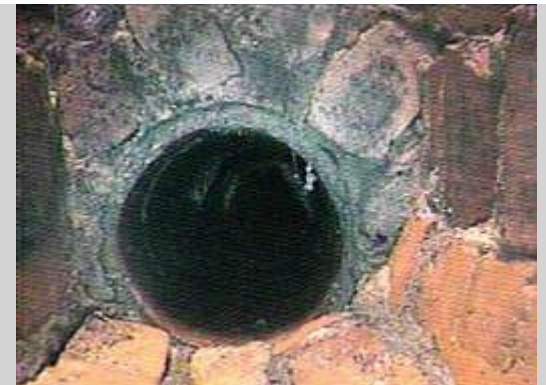
7 O'Clock Inflow

8 in. Circular Gravity Sewer  
Pipe In @ 7 O'Clock

Pipe Height: (in.) Direct  
Pipe Material: **Clay** ☐ Pipe Lined  
Invert Depth: **8.74** (ft.) Flow Characteristics: **None**  
Deposits: ☒ None ☐ Mud ☐ Sludge ☐ Debris ☐ Grease  
Silt Depth: (in.) Deposits Extent:  
Infiltration: **None** Pipe Seal Cond: **Sound**
